## Docket No. 217 - Development and Management Plan Inspection

**Date:** March 23, 2006

Inspector: Don Ukers

Location: 345kV Underground Route

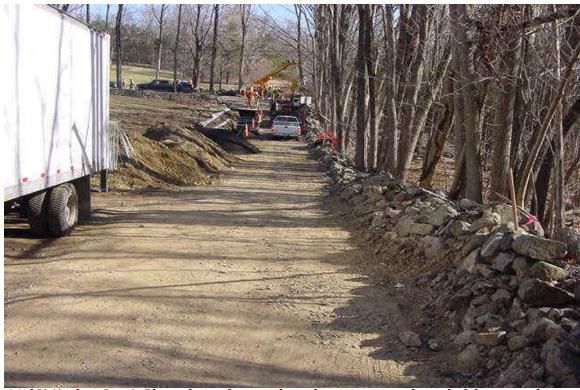
345kV (Archers Lane): Photo shows the trench work continuing at the end of the access drive to the transition station. Watch placement of materials and sediment along the stone wall. 3/23/06

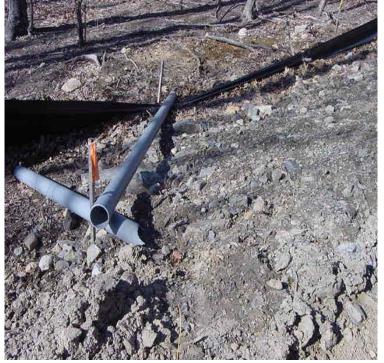
Photo on the left shows some materials placed over the silt fence along the drive to the station. Watch placement of equipment and materials. Photo on the right shows the restored bank at Georgetown Deli still in good shape. 3/23/06

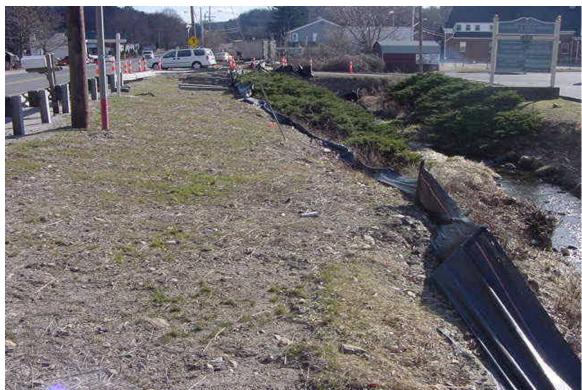
345kV (Rt 107) Photo shows an overview of the area north of Georgetown Deli where some silt fence was down. Controls should be maintained until the area is fully stabilized. 3/23/06

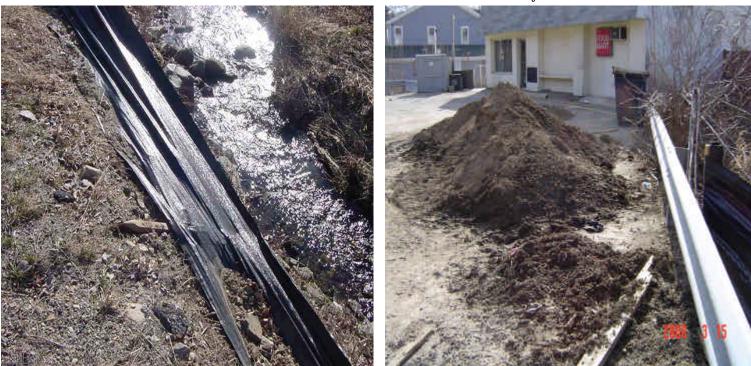
Photo on the left shows a close up of an areas where the silt fence is down. Photo on the right shows a small stockpile by the deli where silt fence still needs to be extended to encompass the pile. 3/23/06

- A small stockpile was noted here in the parking lot beyond the silt fence. 3/9- 3/23/06	- Controls should be extended or this pile should be removed. 3/9-3/23/06

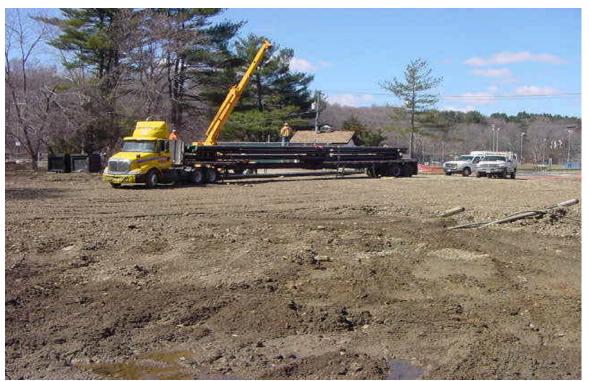
345kV(HDD): The photo shows a view of the HDD site after being regraded where pipe was being delivered. 3/23/06

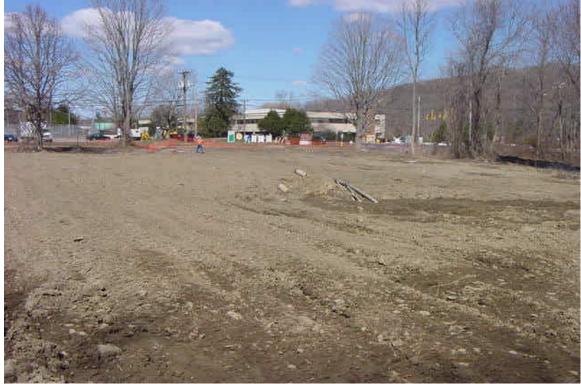
Photo shows another overview of the HDD site where trenching will re-commence soon. 3/23/06
